FEDERAL AVIATION ADMINISTRATION
AIRWORTHINESS DIRECTIVES
SMALL AIRCRAFT, ROTORCRAFT, GLIDERS,
BALLOONS, & AIRSHIPS

BIWEEKLY 2000-03

2000-02-09 AGUSTA: Amendment 39-11528. Docket No. 98-SW-69-AD.

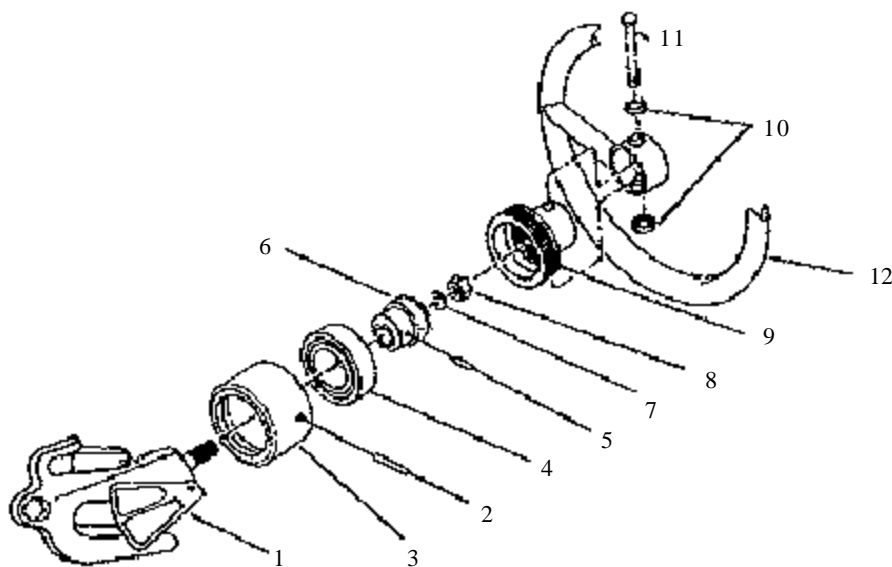
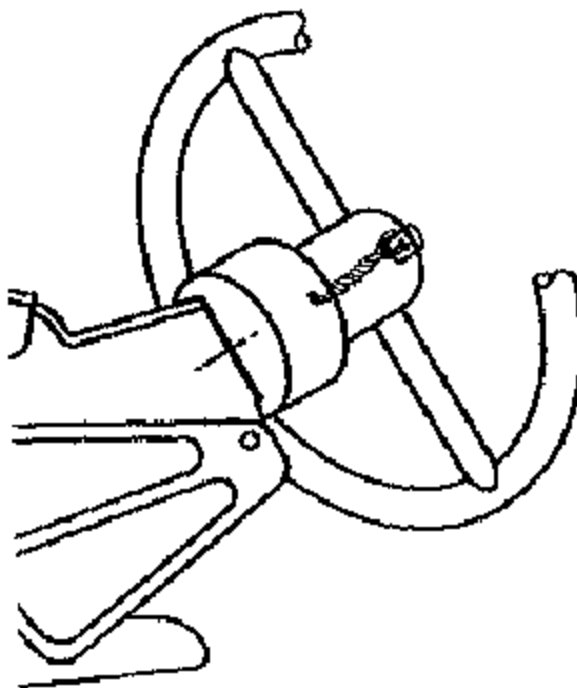
Figure 1 of 1
AD 2000-02-09

To prevent separation of the rescue hoist hook assembly from the helicopter due to failure of the rescue hoist hook assembly retention pin (retention pin), accomplish the following:

(2) Remove the safety wire and remove and discard the retention pin. Retain the two washers, P/N AN960C816L, for reuse (Figure 1).

(3) Inspect the pin, P/N NAS516C4-6 or P/N MS171524, installed on the housing, P/N BL1357-1, and verify the absence of any rotation between the housing and the adapter, P/N BL1355, (Figure 1).

(4) Inspect the rescue hoist hook to ensure it rotates freely relative to the housing (number 3 on Figure 1).

(1) Referring to Figure 1, remove the safety wire and the retention pin. Retain the two washers, P/N AN960C816L, for re-use. Inspect the retention pin for scratches or deformations. If a scratch or deformation is found, replace the retention pin with an airworthy retention pin.

(a) Before further flight, replace the retention pin, part number (P/N) BL2395, of the rescue hoist hook assembly, P/N S6150-61090-1, as follows:

(3) Install a zero-hours time-in-service (TIS) retention pin, P/N BL2395, and the two washers, P/N AN960C816L, (Figure 1). Safety wire the retention pin to the hook assembly using safety wire, P/N MS 20995C32.

(2) Install the retention pin and the two washers, P/N AN960C816L, (Figure 1). Safety wire the retention pin to the hook assembly using safety wire, P/N MS20995C32.
